TEST REPORT

No. : NBIN1804003775PS

Sample Name : PVC Fence
Product Specification : 5"x5"Post,7/8"x6"T&G
Manufacturer : ZHEJIANG SHOWTECH OUTDOOR PRODUCTS CO.,LTD

Test Item: Striker Impacted by a Falling Weight

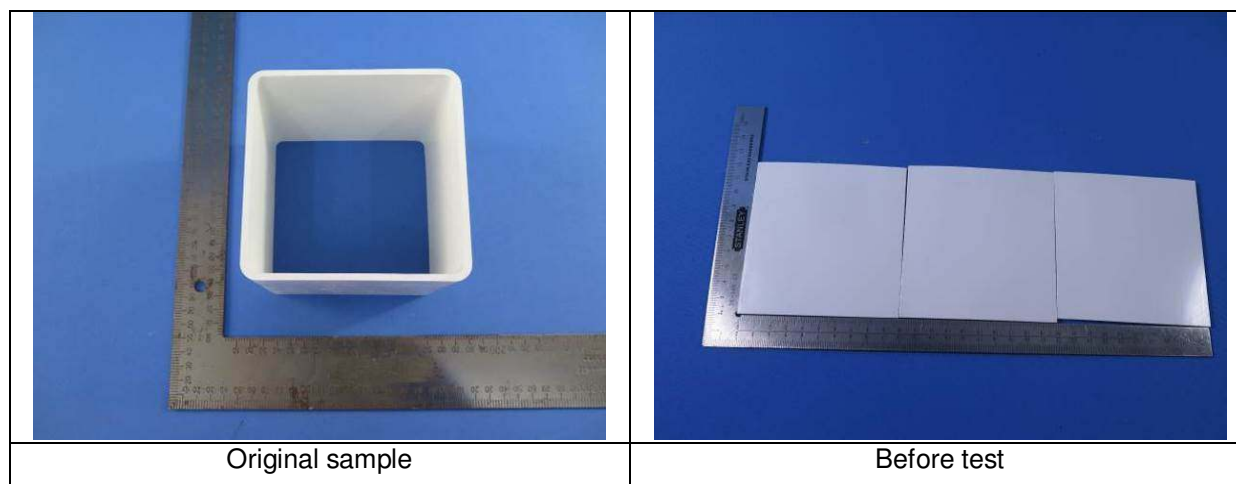
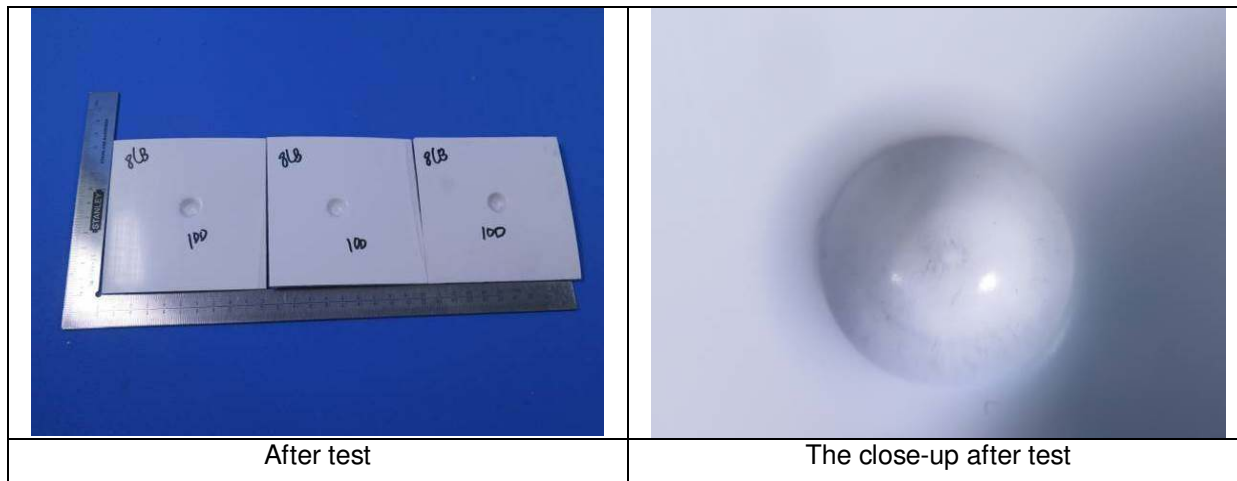
Test Photo:

Sample Description: White plastic part

Test Method: ASTM D4226-11 Procedure A and client's requirement

Pretreatment: -30°C, 24h

Specimen thickness: 4.01mm

Geometry: H.25

Strike weight: 3.6kg

Sample	Test Result
1	Mean failure height: $\geq 100\text{cm}$
	Mean failure energy: $\geq 35.3\text{J}$
